# Parametric analysis of groundshock loading on steel plates and reinforced concrete slabs

Thesis submitted to the University of Sheffield  
for the degree of Doctor of Philosophy

**University of Sheffield**  
**Department of Civil and Structural**  
**Engineering**

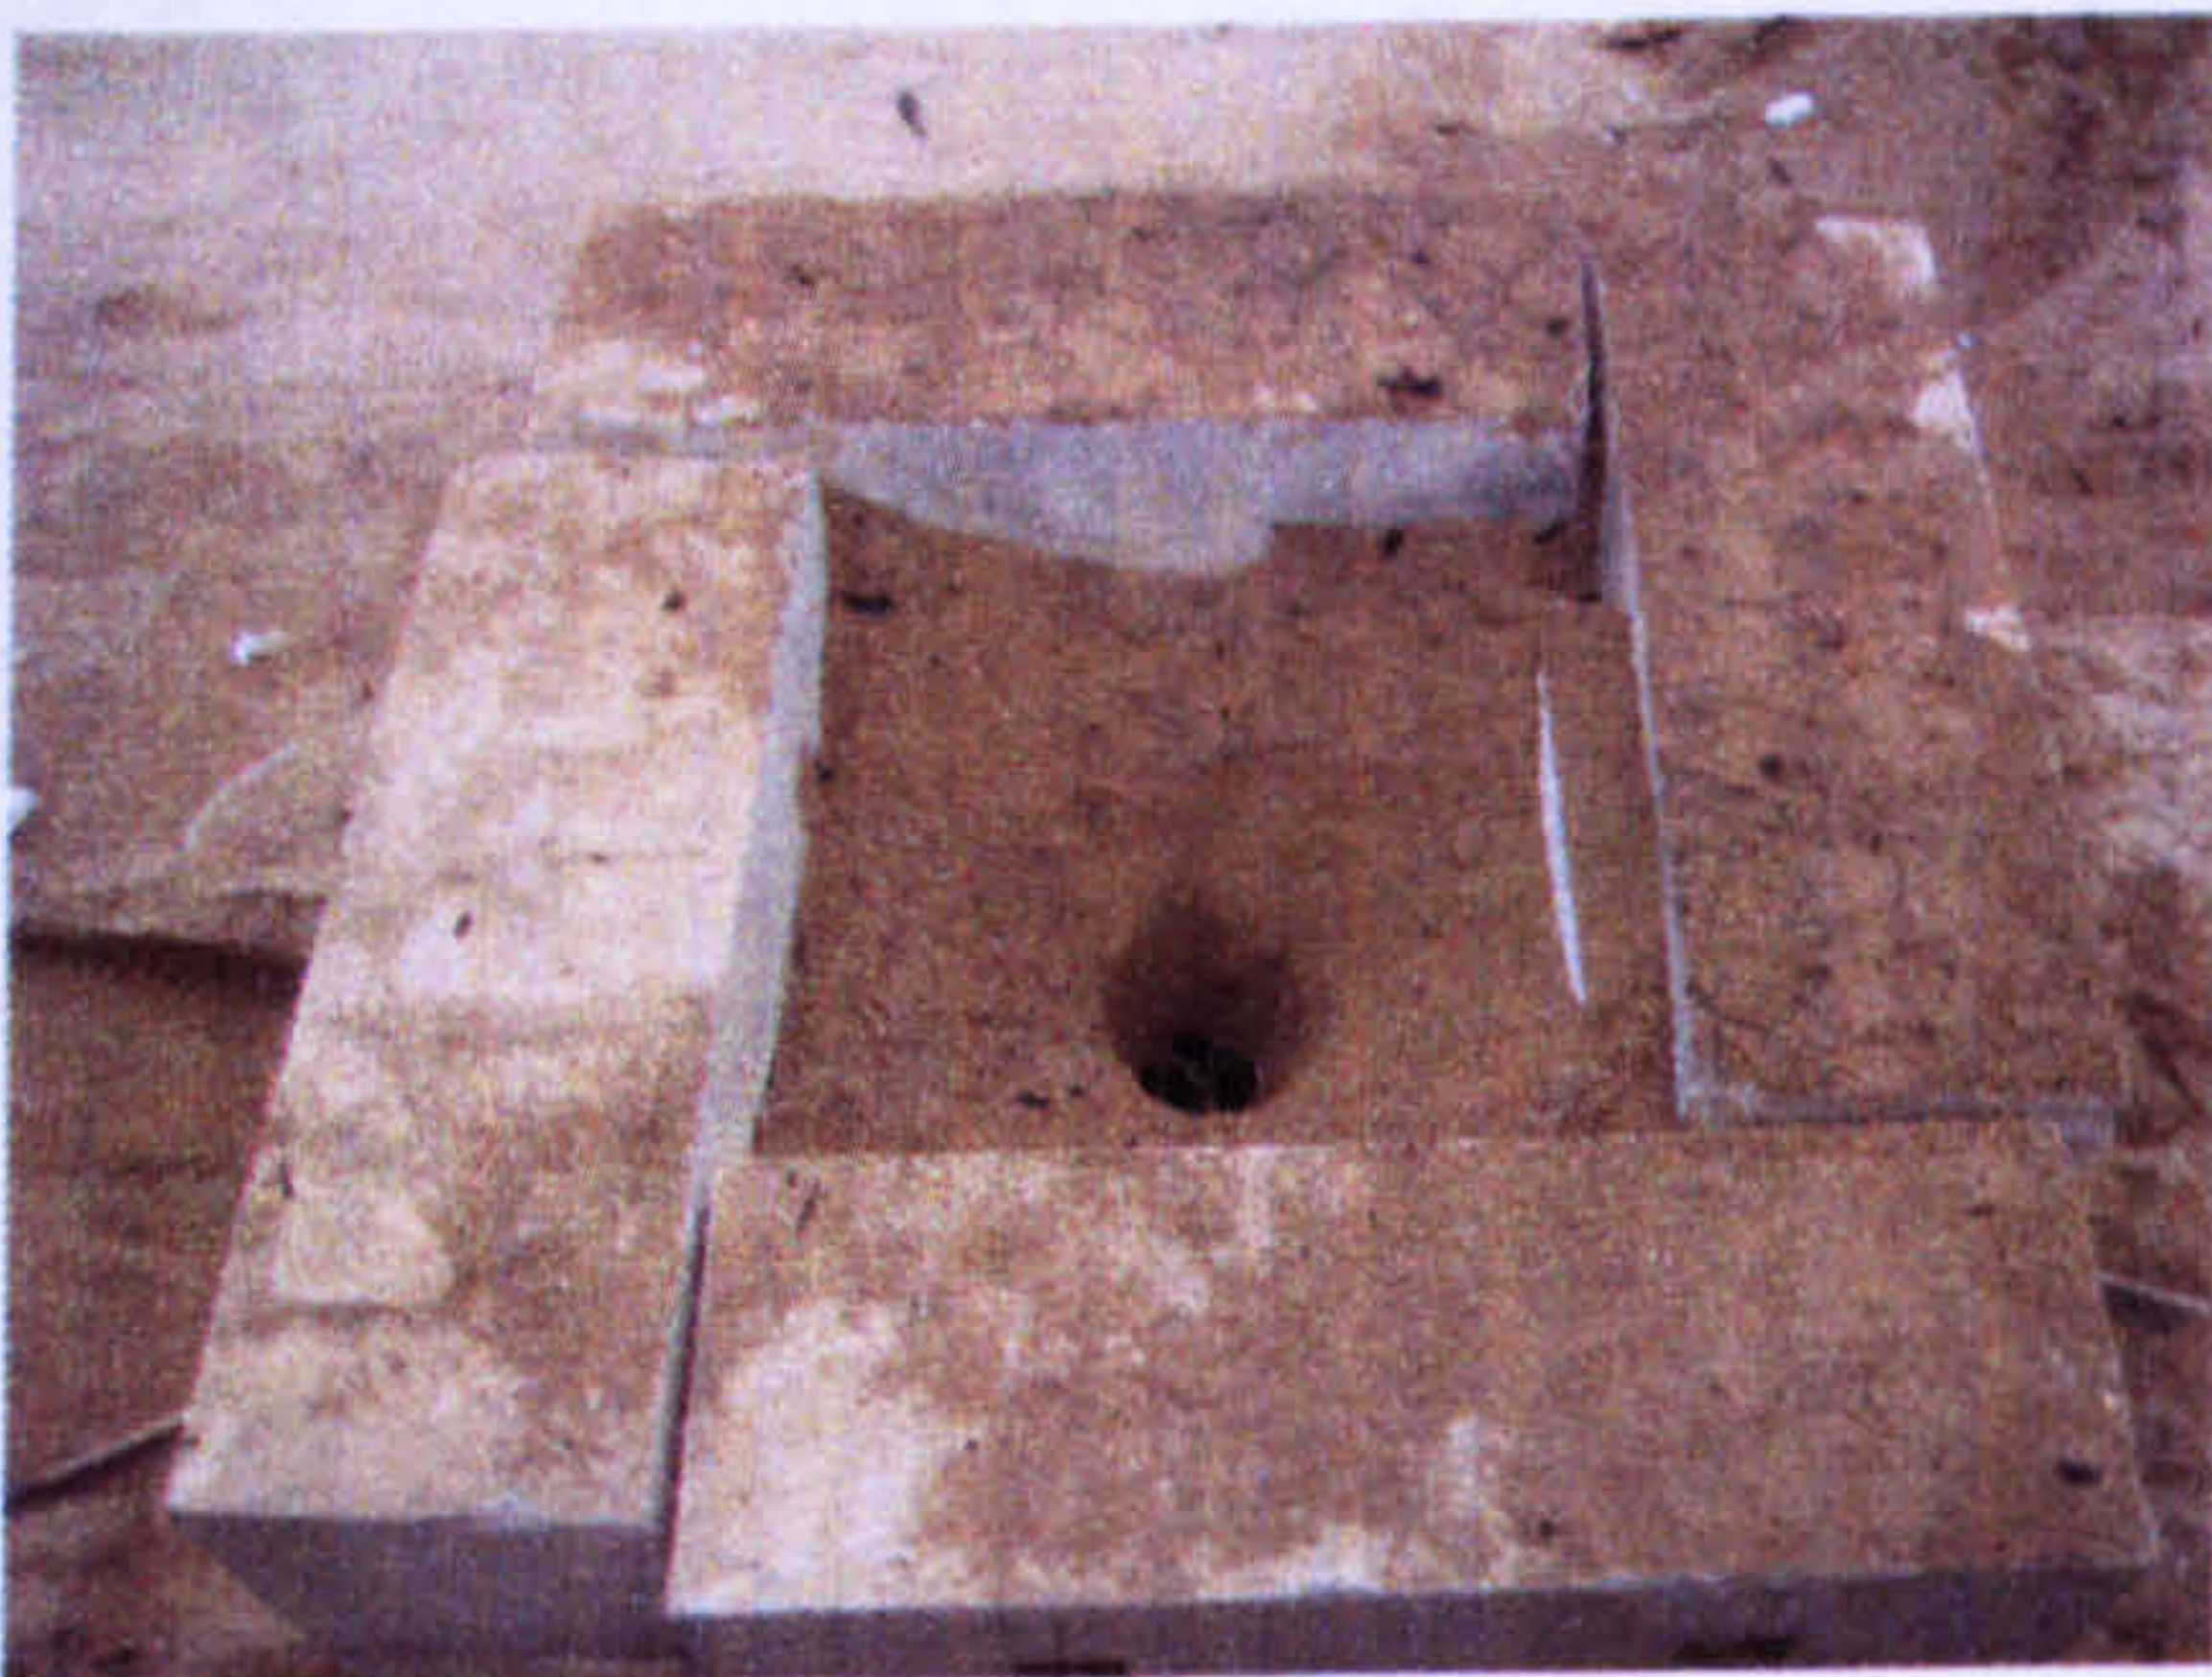
Plan elevation of the test cell

It was suspected that the first two cumulative hits had weakened the primary slab such that there was a loss in its structural strength and stiffness due to pre-damage. This allowed the third hit to cause major perforation. Cracking was observed on the top and bottom faces after the first two tests but not to such an extent that suggested that a perforation could develop. The third cumulative hit caused a massive central perforation equivalent to 10% of the area of the slab. The effect caused a cylindrical volume of soil to pour through the perforated hole in the slab leaving a void, as illustrated in plate 4.3.6.

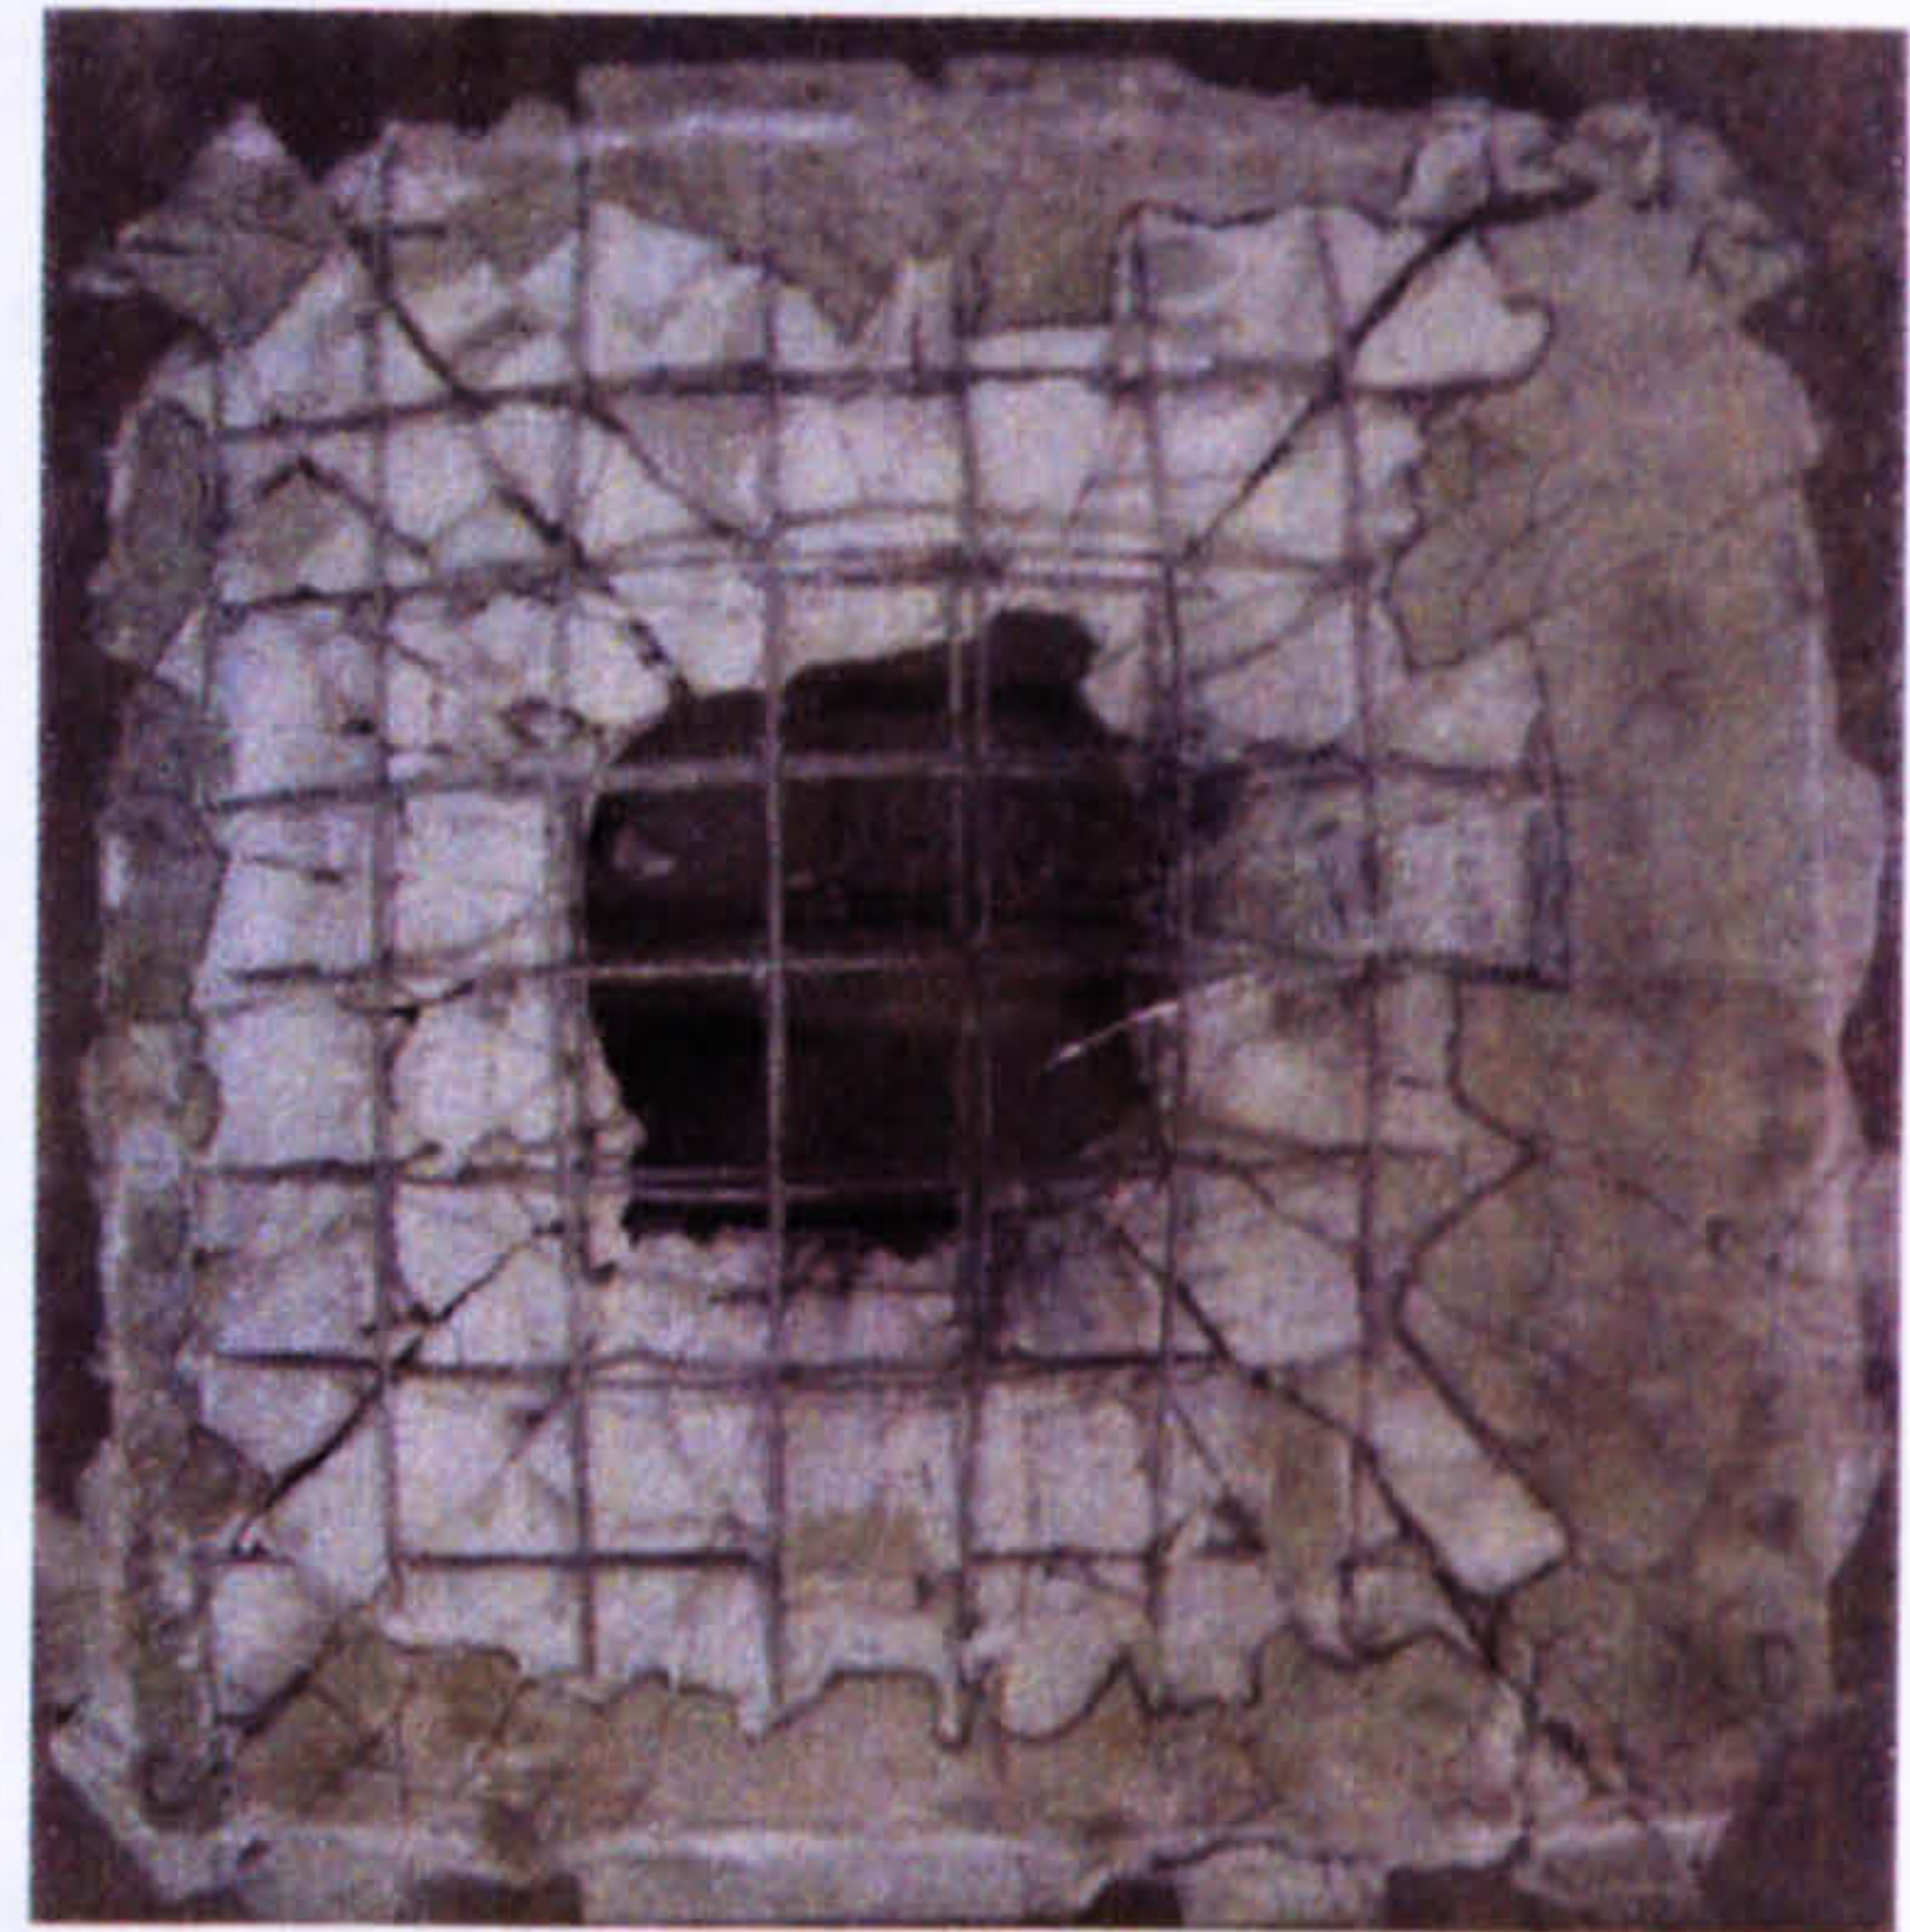
**Plate 4.3.12 Top and bottom faces of the primary slab RCR73IT17-19 with a secondary slab omitted.**

Bottom face

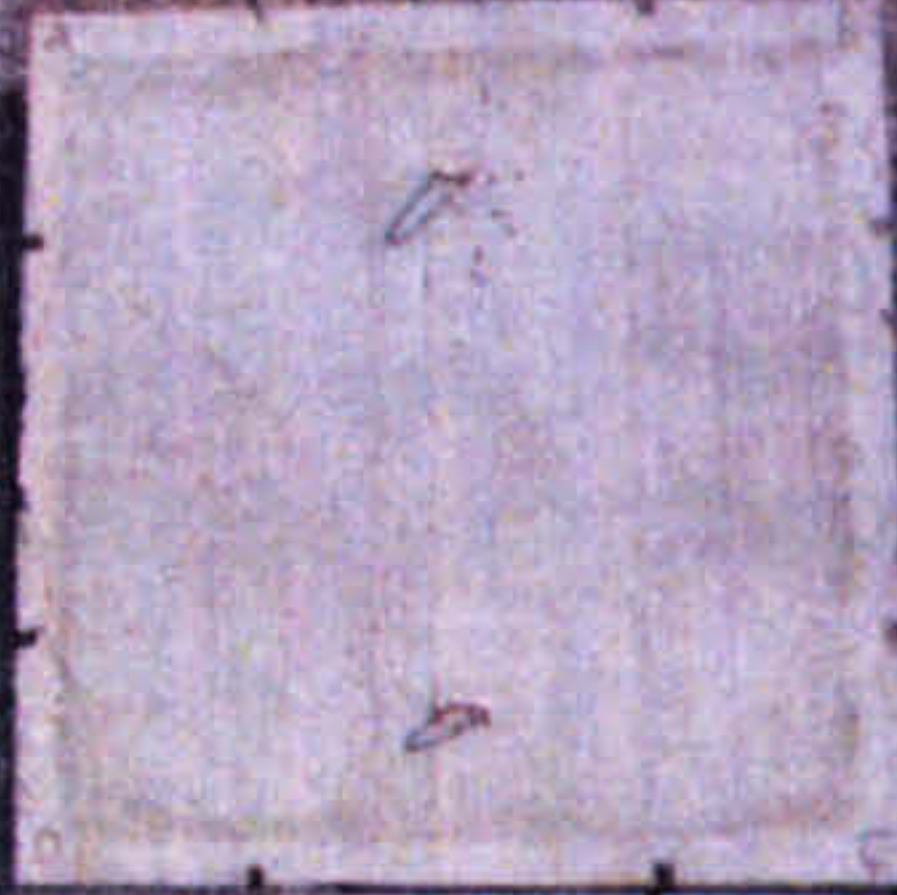
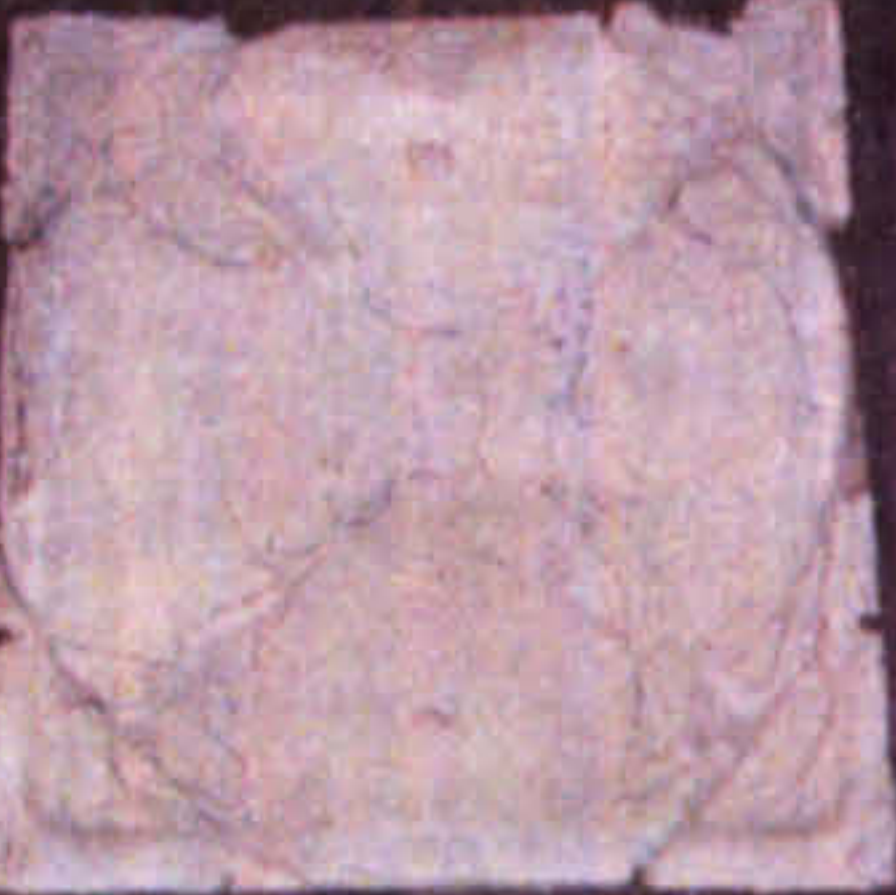
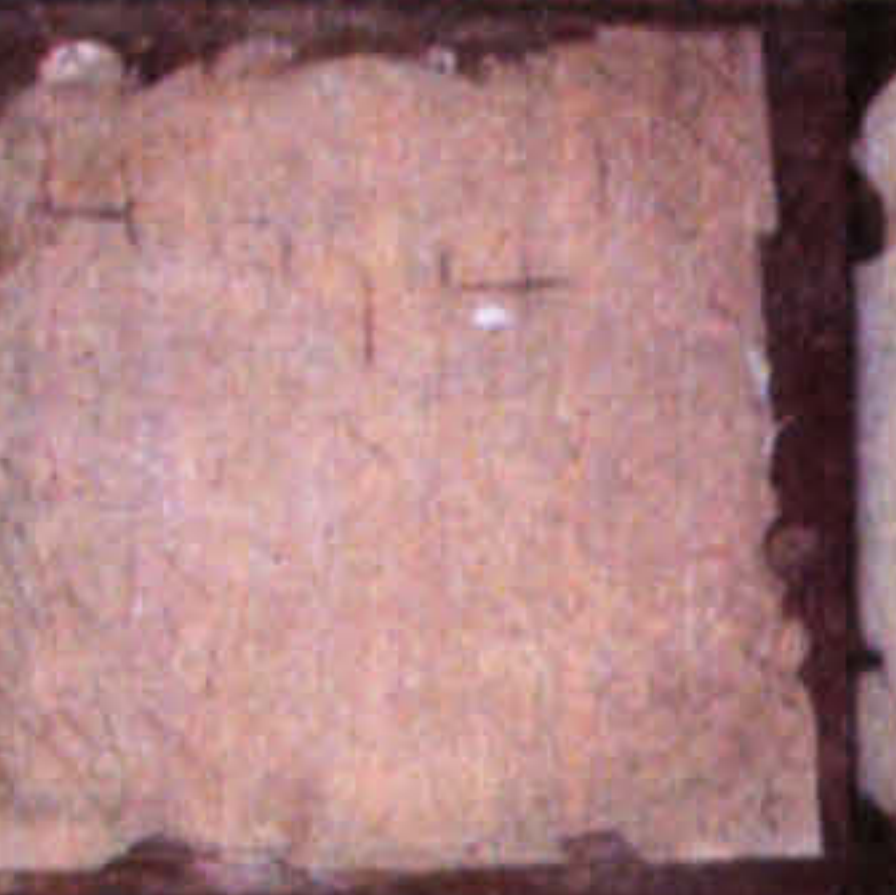
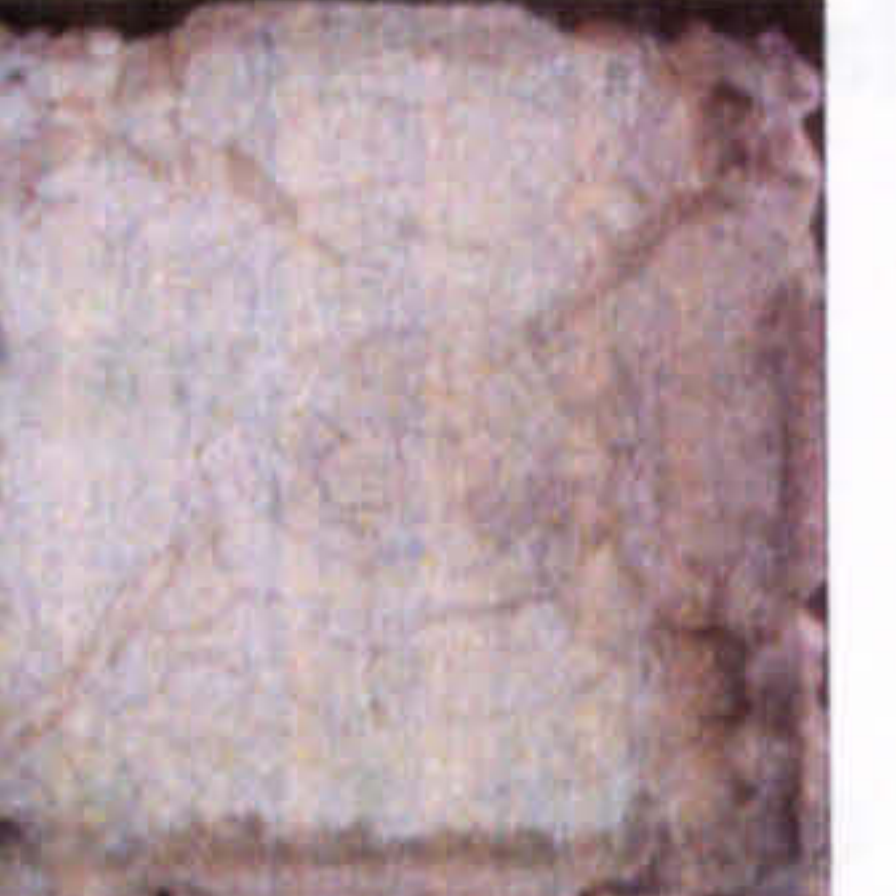
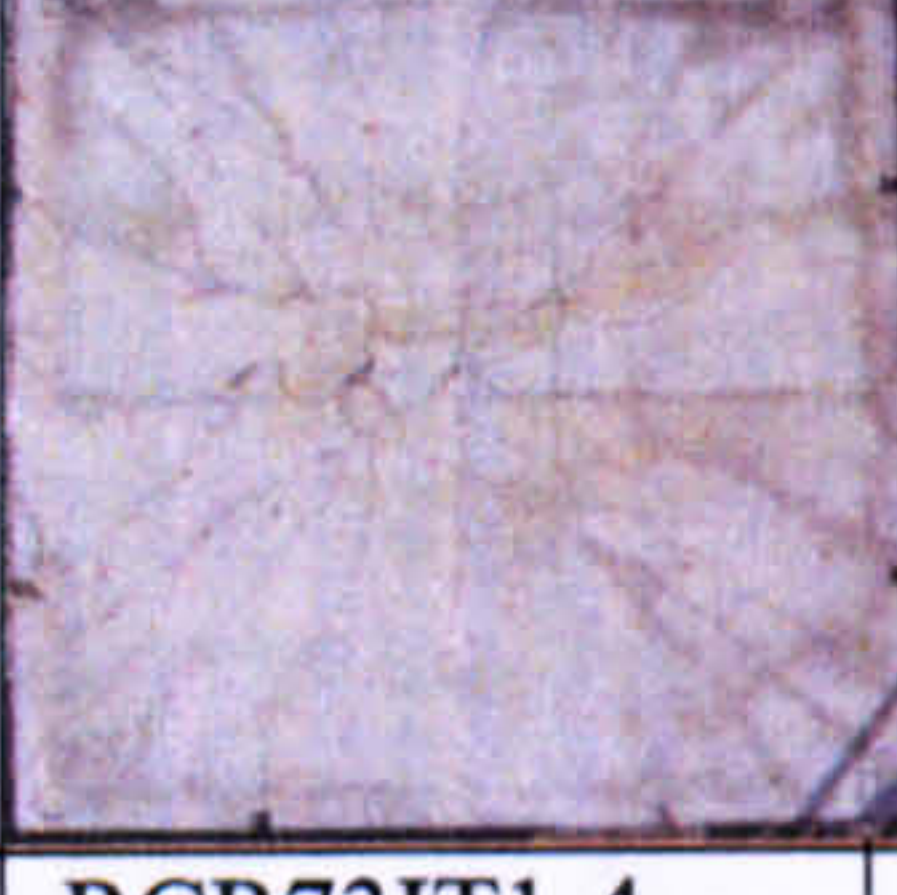
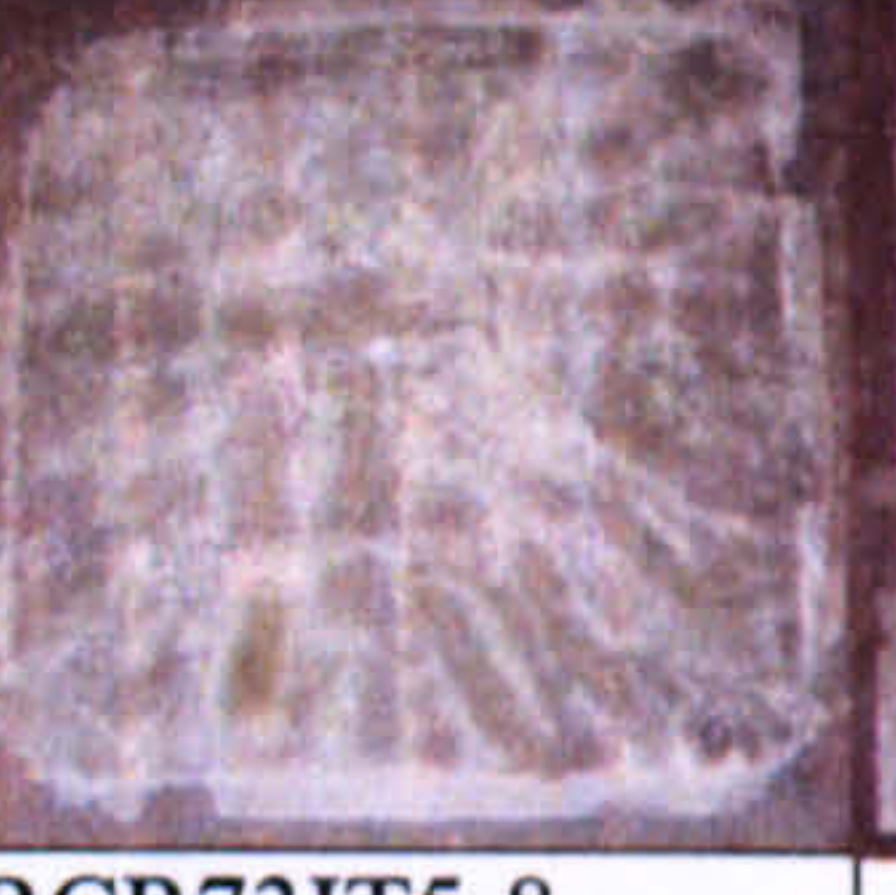
**Table 4.5.1 Cumulative damage inflicted upon the primary slabs from Stage I of the test matrix**

Group 1 tests	Group 2 tests	Group 3 tests	Group 4 tests
Top face

Bottom face

Slab	RCR73IT1-4	RCR73IT5-8	RCR73IT9-11	RCR73IT12-13
Cumulative hits	4	4	3	2
Charge standoffs (mm)	540,440,350,300	340,240,150,100	190,90,0	113,13

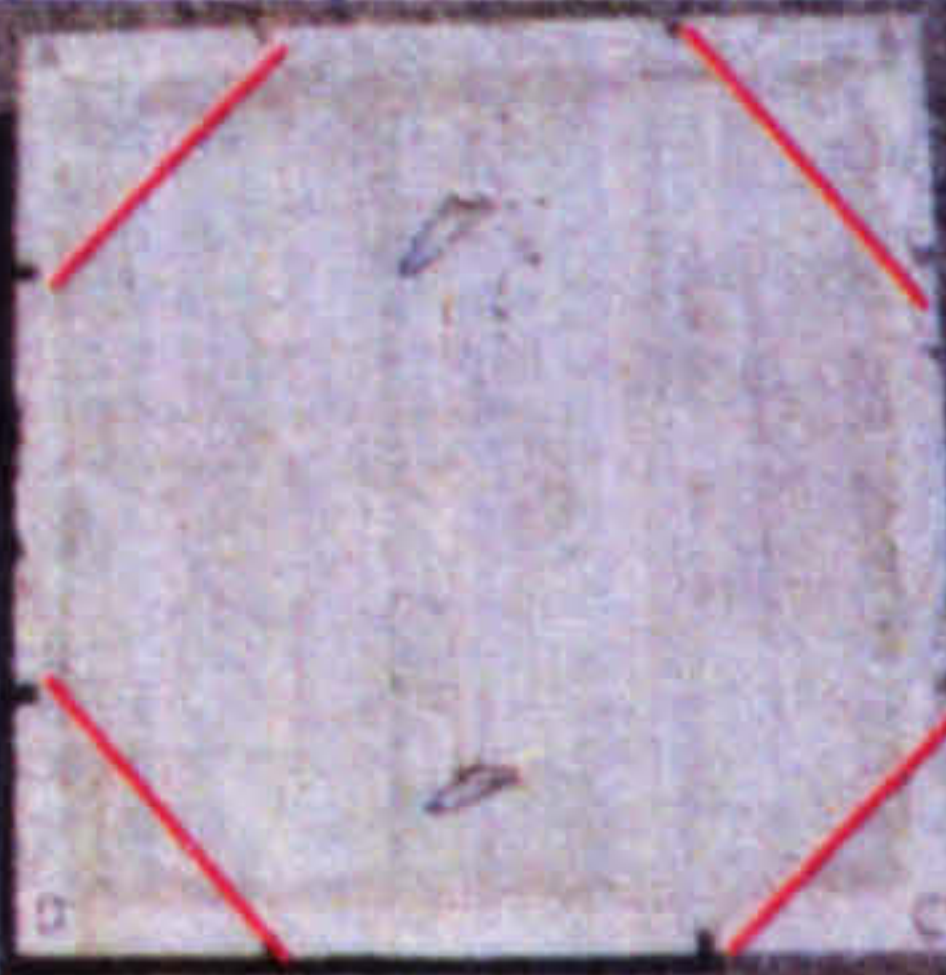
**Table 4.5.2 Simplistic crack patterns inflicted upon the primary slabs in Stage I.**

Group 1 tests	Group 2 tests	Group 4 tests
Top face

Slab	RCR73IT1-4	RCR73IT5-8	RCR73IT12-13
Chronological order of the damage modes	1. Corner cracks	1. Corner cracks & spalling. 2. Diagonal cracks 3. Central square cracking	1. Corner cracks and spalling. 2. Diagonal cracks and spalling. 3. Central circumferential cracking 4. discontinuous circumferential cracking within the four quadrants
Cumulative hits	4	4	2
Charge standoffs (mm)	540,440,350,300	340,240,150,100	113,13

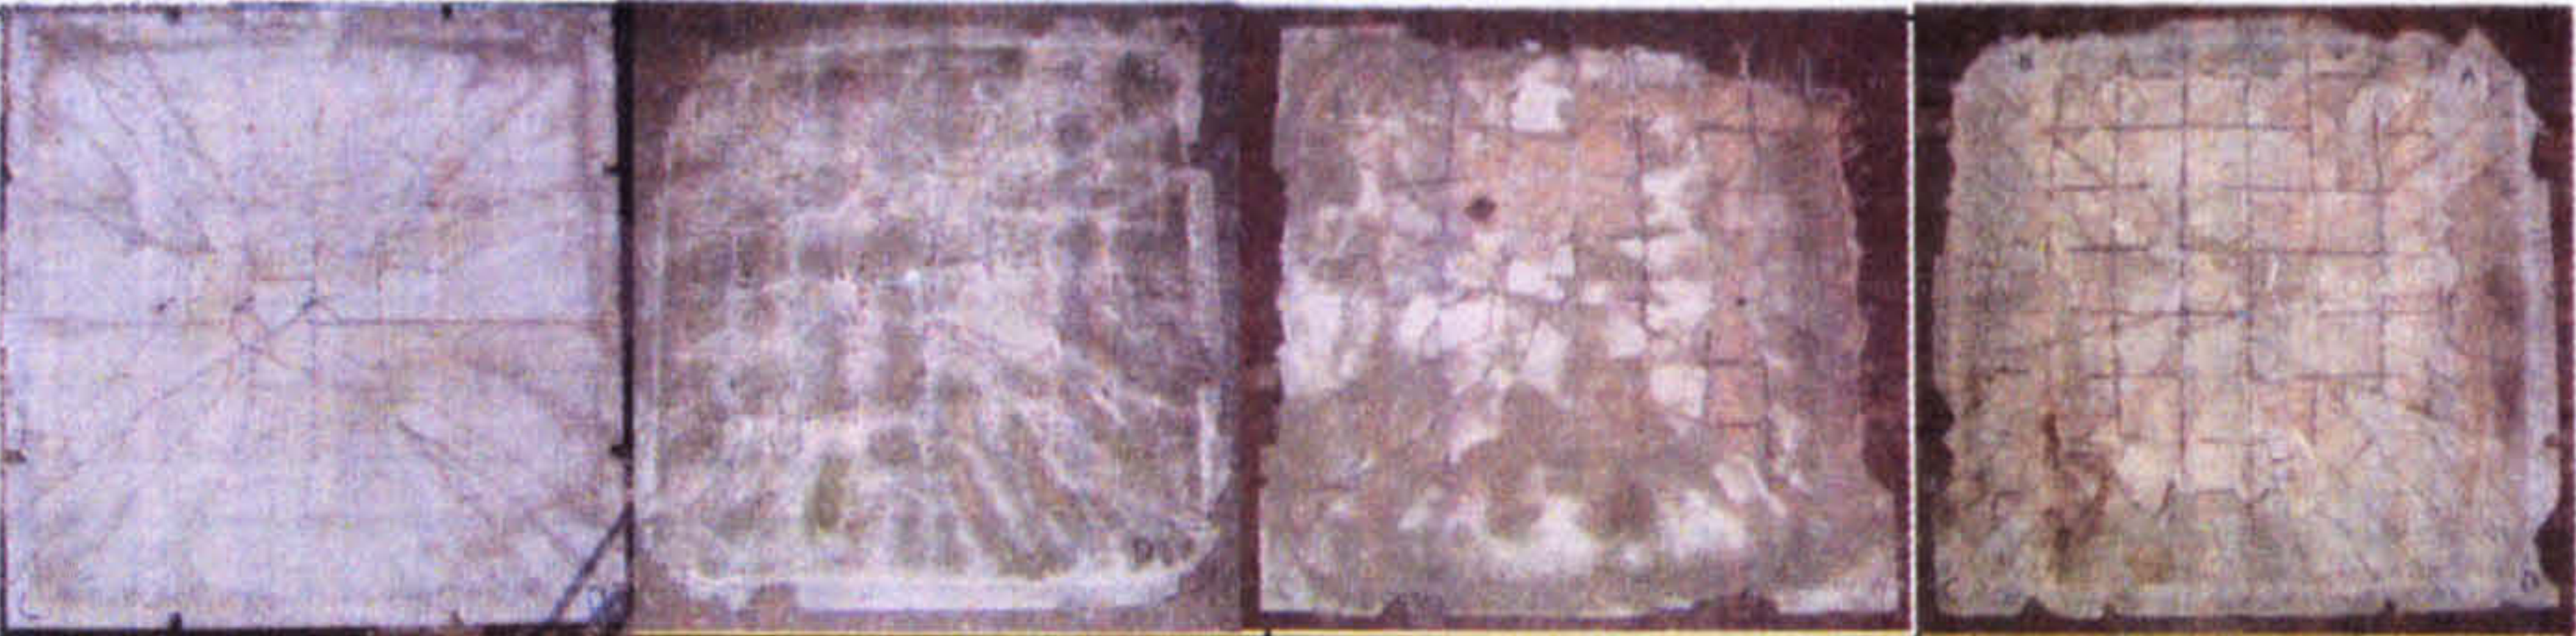
Table 4.5.3 Cumulative damage inflicted upon the primary slabs in Stage I.

Bottom face

Slab	RCR73IT1-4	RCR73IT5-8	RCR73IT9-11	RCR73IT12-13
Cumulative hits	4	4	3	2
Charge standoffs (mm)	540,440,350,300	340,240,150,100	190,90,0	113,13

The damage to the top and bottom faces of the slabs have been classified and illustrated in table 4.5.4. The procedure adopted was not universal to damaged concrete slabs. However, the idea was taken from the work performed by **Duranovic (1994)**.

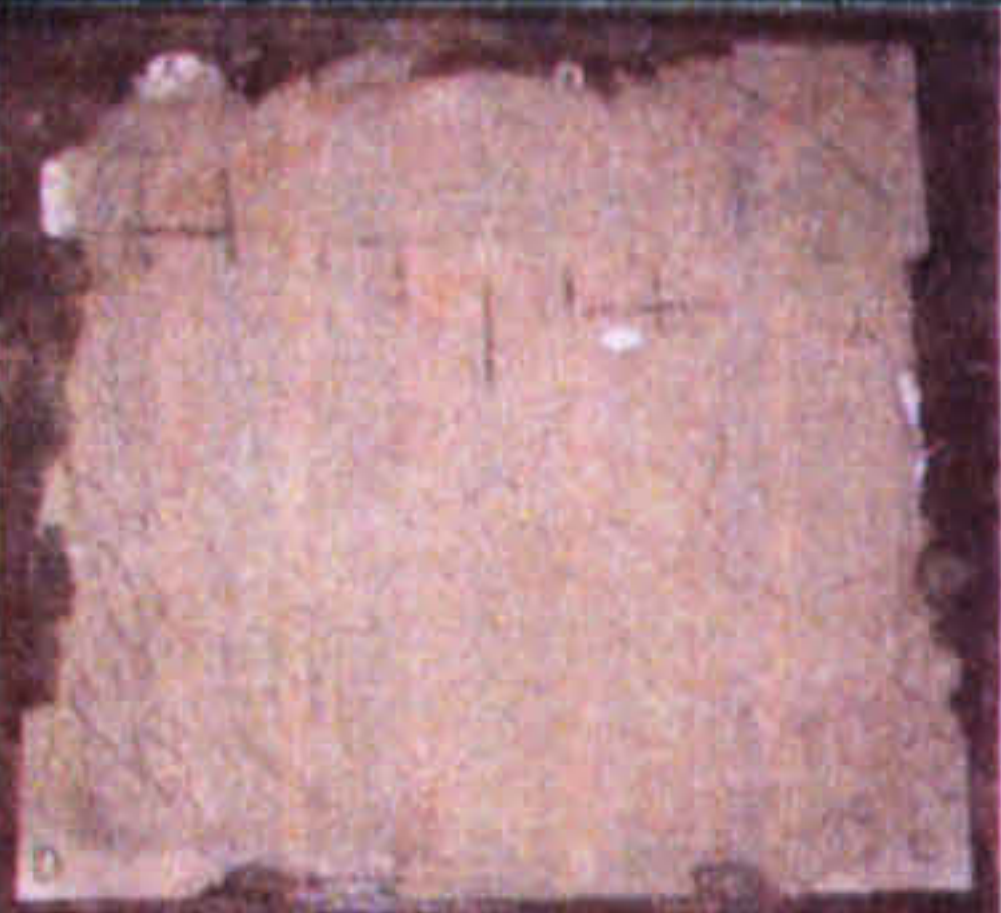
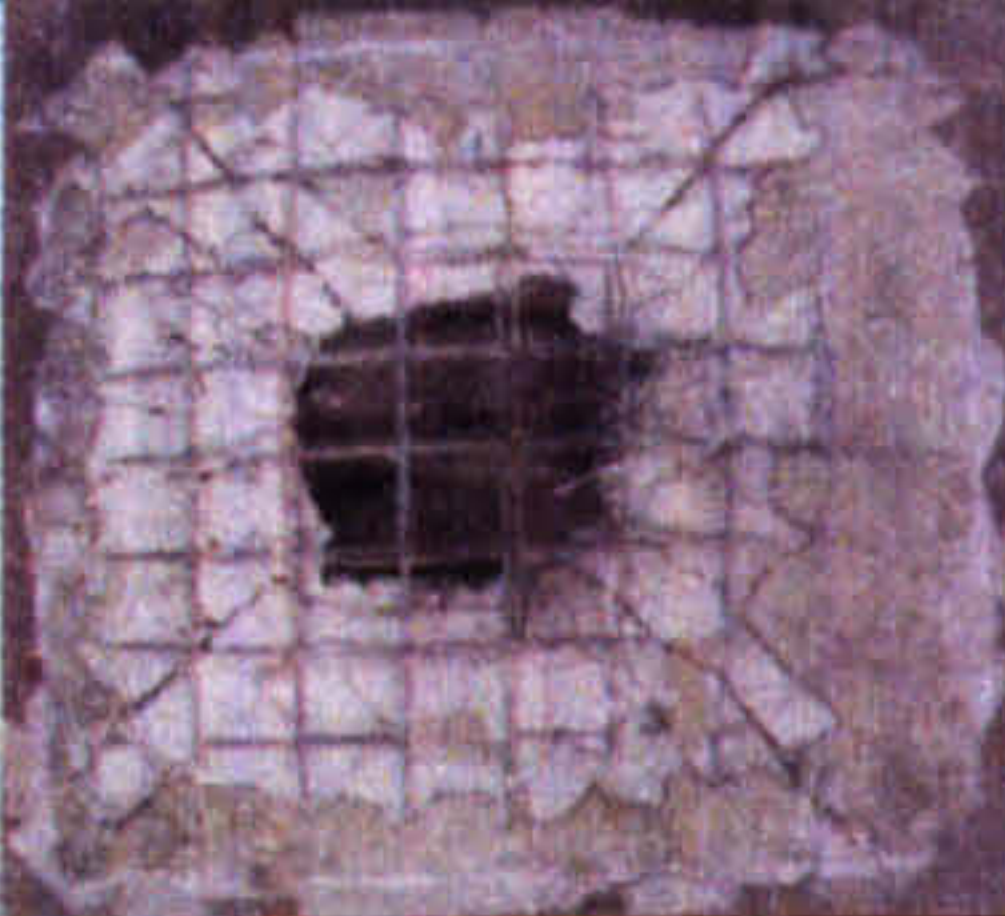
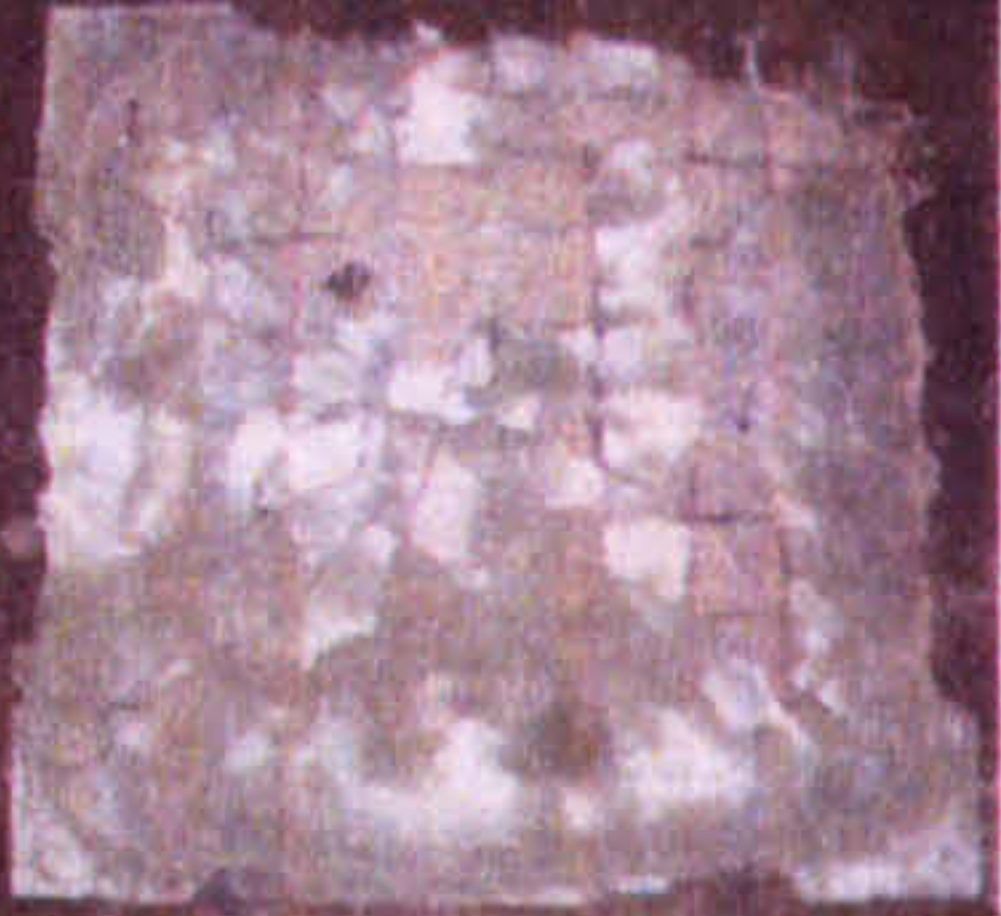
**Table 4.5.5 Damage comparison to two primary slabs subjected to cumulative loading with secondary slabs omitted and positioned within the soil overburden.**

Secondary slabs omitted	Secondary slabs positioned
Top face

Bottom face

Hits	3	3

It is reasonable to assume that the third cumulative hit, a contact charge, would have induced similar magnitudes of loading into both the primary slabs. The first and second cumulative hits would have caused weakening to both the primary slabs, with a greater degree inflicted upon the unprotected primary slab.

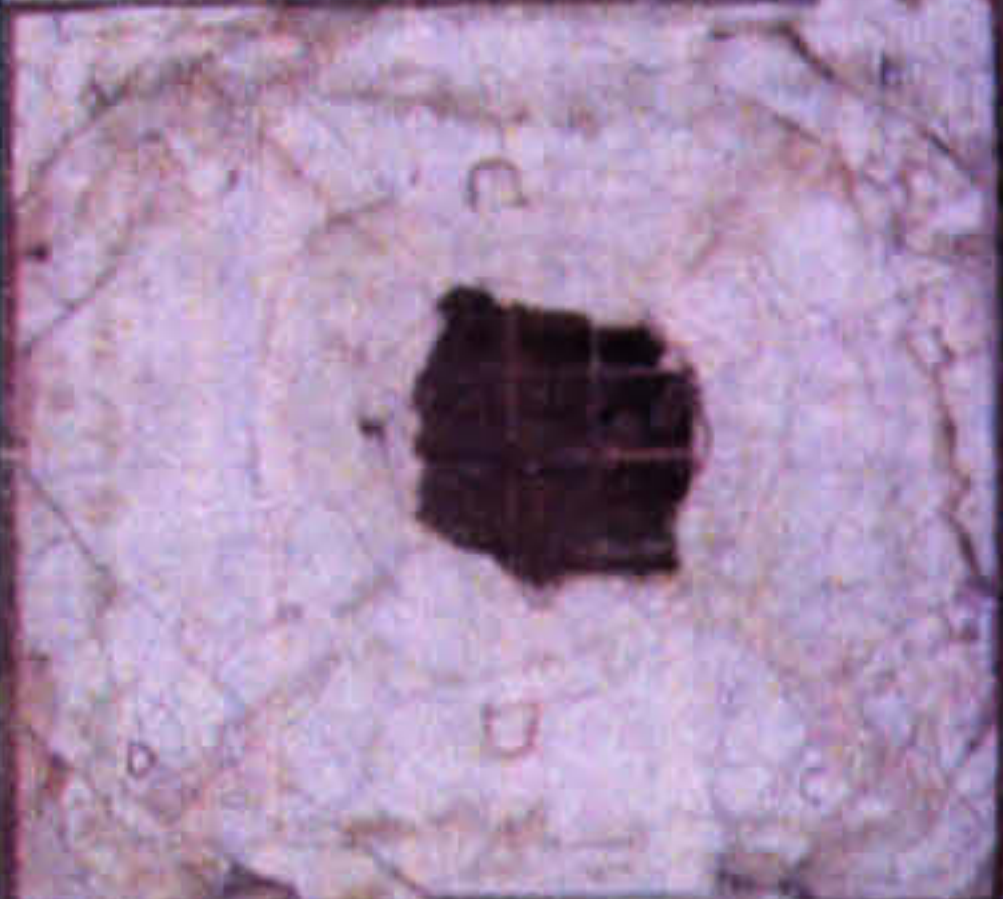
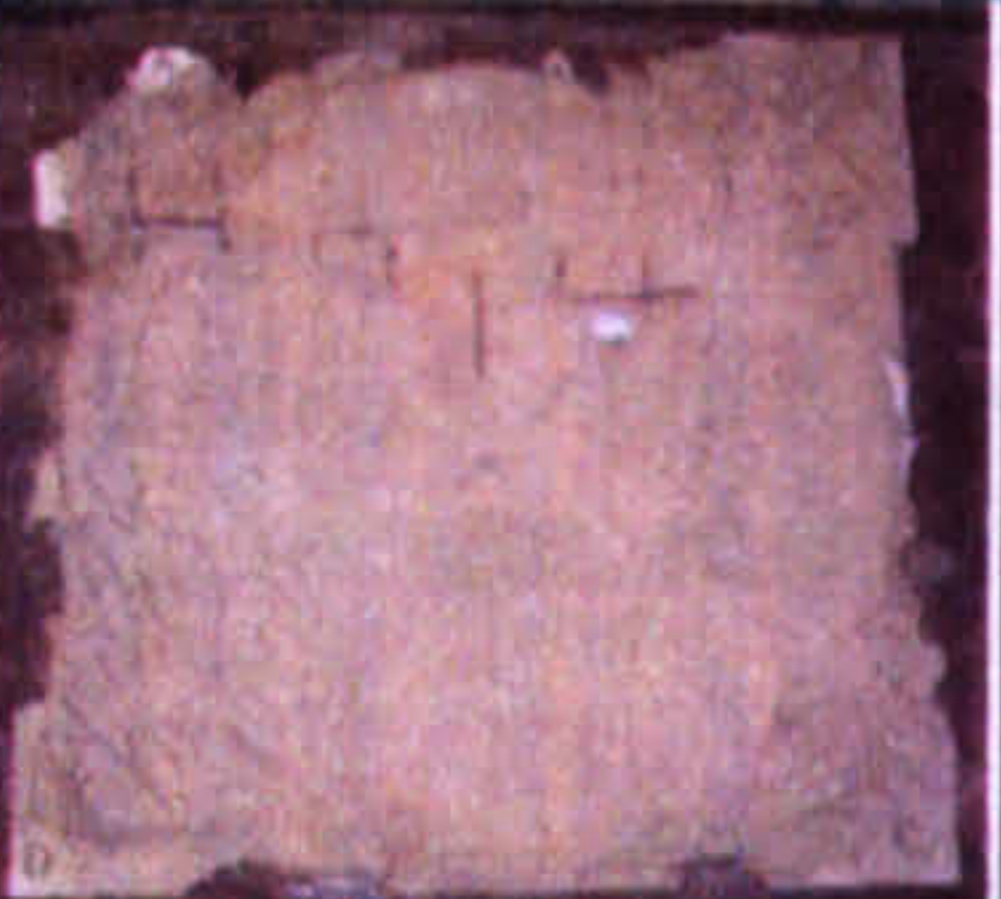
**Table 5.4.1** Damage comparison to two primary slabs subjected to cumulative loading with secondary slabs omitted and positioned within the soil overburden

Secondary slabs omitted	Secondary slabs positioned
Top face

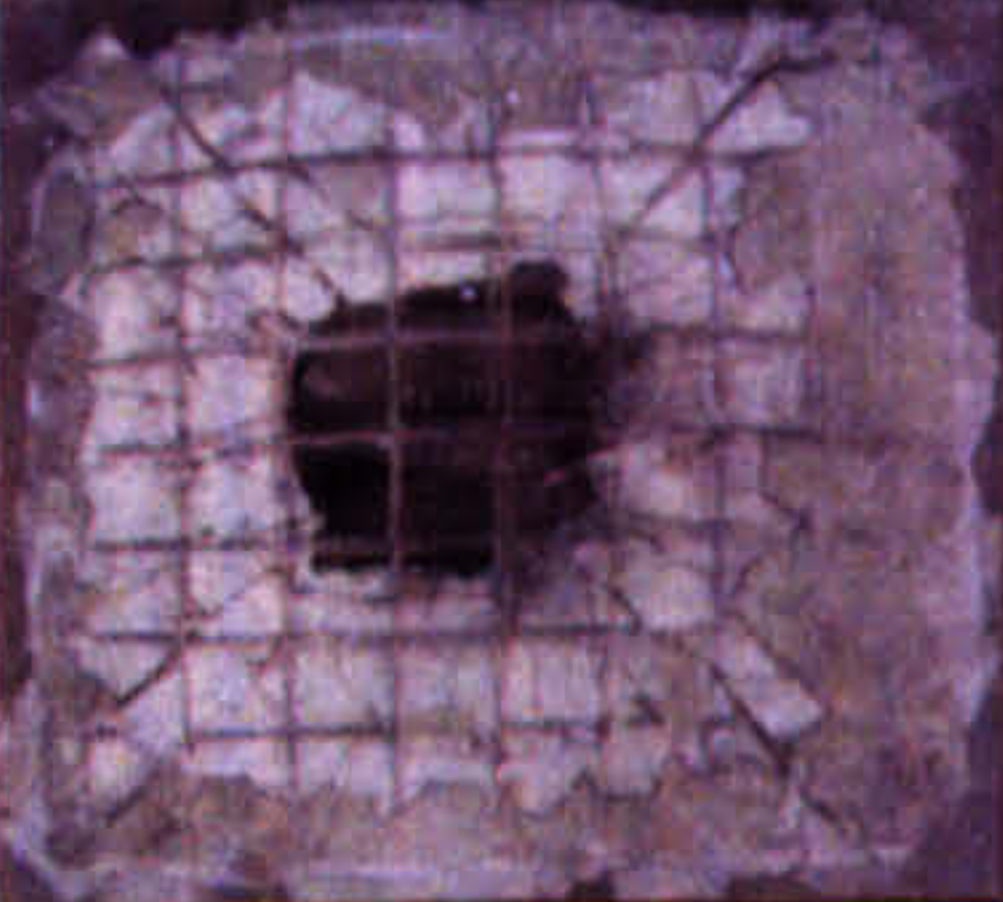
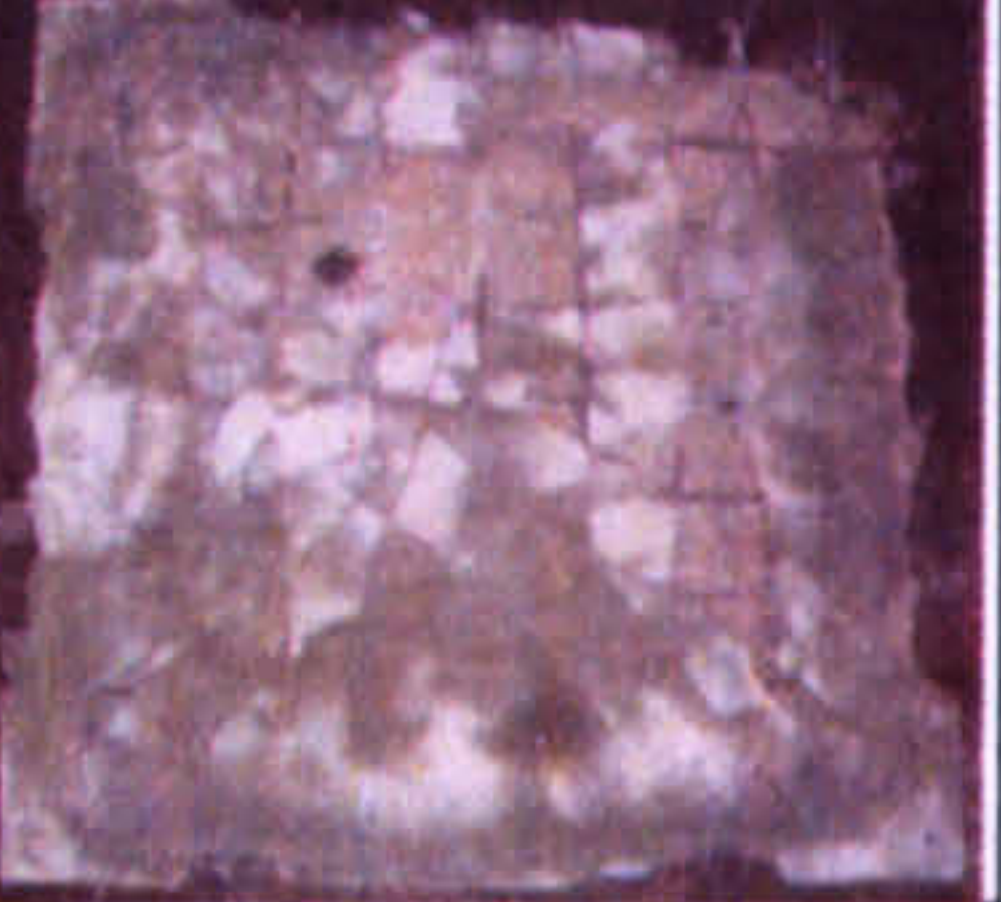
Hits	3	3

Secondary slabs omitted – unprotected primary slab  
Secondary slabs positioned – protected primary slab

**Deng *et al* (2004)** differentiated between the effects of perforation and punching of concrete fragments. A concrete fragment expelled by punching action would have a greater mass travelling at a larger velocity. This would have a detrimental effect on the internal space within a structure. The damage to the unprotected primary slab RCR73IT17-19 as illustrated in table 5.4.1 indicated punching action of the concrete. This caused the removal of a concrete section, evident after the test. Anti-scabbing plates attached to the bottom face of a slab as used by **Pope (2002)** would have prevented this.

The findings from Stage III of the test matrix indicated that the impulse histories rather than a single induced impulse, caused by a contact charge, significantly increased the severity of damage to a primary slab with the assistance of internal weakening.
